## LANDSLIDES AND RELATED FEATURES

OF THE BEANS CREEK, TENN. QUADRANGLE

by ROGER E. THOMAS 1982

U.S. Geological Survey Open File Map 82-750 (A-15)

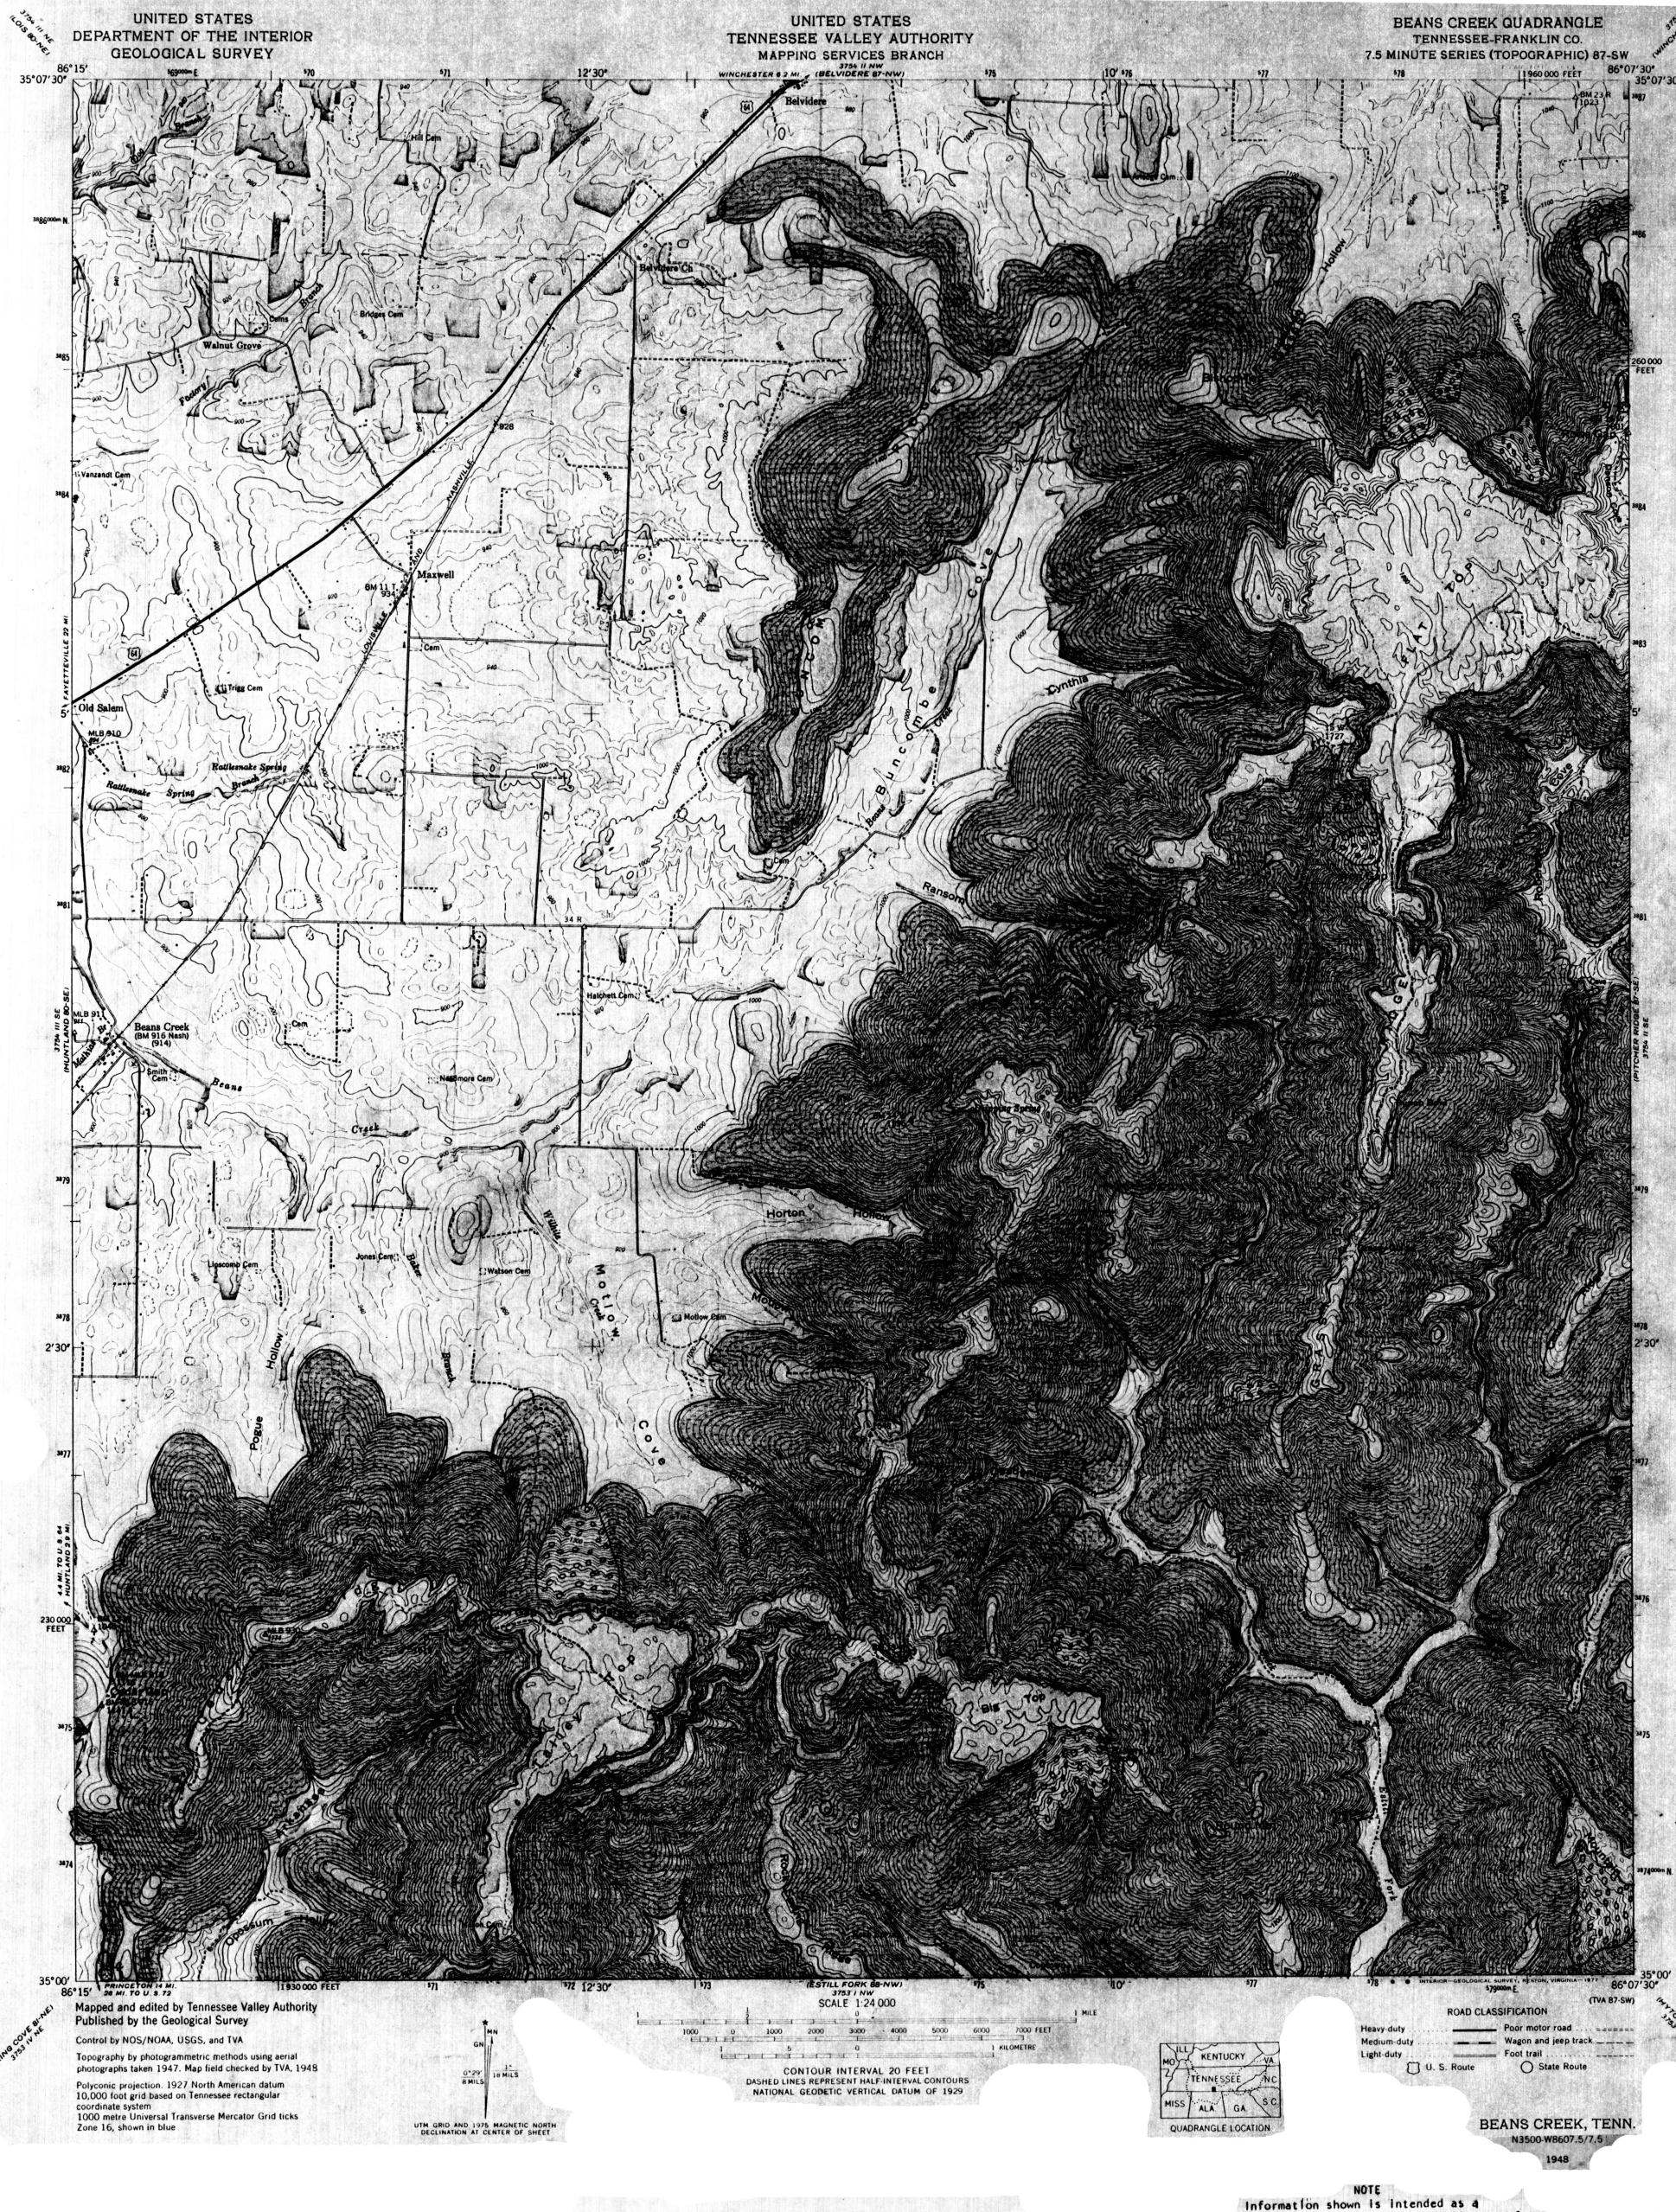
Landslides and related features interpreted from aerial photographs: 1:40,000 (black and white) 1976

Photointerpretation and field check 1980-1981 This report is preliminary and has not been reviewed for conformity with U.S. Geological Survey editorial standards.

ACTIVE OR RECENTLY ACTIVE LANDSLIDE Complex landslide composed of earthflow, debris slide, earth and rock slump. Identified from historical records, and from scars, debris and other field evidence. Ground extremely unstable; sliding accelerated by excavation, loading and changes in drainage conditions. May include areas with several active slides too small to be shown separately. Questioned where doubtful.

OLD LANDSLIDE Area of extensive hummocky ground caused by earthflow and earth and rock slump. Lacks clear evidence of active sliding. Relatively stable in natural, undisturbed state, generally not affected by small structures properly sited in areas away from the edge of the toe; can be reactivated by extensive, mapid excavation, loading, and changes in ground water and surface water conditions. Area of old landslide probably includes recent ones not identified from field evidence or otherwise documented. Upslope boundary of landslide generally defined

COLLUVIAL SLOPE Valley wall along major streams with slope as steep as 40° (85%); stony, clayey silt soll up to 50 ft. (15 m) thick; commonly buttressed by a terrace or bench at the toe of the slope; very susceptible to sliding by cutting of toe area, removal of terrace or bench, and overloading; slide commonly activated without apparent cause.

AREAS SUSCEPTIBLE TO DEBRIS FLOWS AND DEBRIS AVALANCHES

Primarily shallow, narrow ravines and chutes with accumulation of stony colluvium generally 10 ft. (3 m) or less in thickness; susceptible to rapid movement during intense rainfall. Most ravines and chutes designated show evidence of former debris flows and avalanches.

AREAS SUSCEPTIBLE TO ROCKFALL Steep, locally vertical, natural and man-made slopes and cliffs, 15 ft. (4.5 m) or more high; formed dominantly of sandstone, limestone, sandy shale, mudstone and claystone. Interbedded mudstone, claystone and shale weather rapidly leaving sandstone and limestone rock faces unsupported.

SOIL AND ROCK SUSCEPTIBLE TO LANDSLIDING Soil and rock similar to that involved in landslides elsewhere in map area; primarily areas underlain by claystone, mudstone and shale associated with other rock types. Rock weathers rapidly on exposure forming clayey soil highly susceptible to sliding. Includes coves (U-shaped, shallow valleys) containing thick layers of clayey soil that are very susceptible to sliding where excavation breaks continuity of slope and where overloaded by artificial fill.

AREAS LEAST PRONE TO LANDSLIDES Map areas in which no patterns or symbols are shown primarily valley floors, ridge tops and broad benches; modification by excavation and fill may lead to local landslides.

general gulde to ground conditions as of the date of field check. Additional landslides and rockfalls should be anticipated In all map units. The map unit depicts the dominant condition in the area delineated and variations in slope stability may occur at any point in the unit. This map is suitable for general planning purposes and as a supplement to more detailed studies for site selection. The map cannot be used as a substitute for detailed geologic and engineering investigations to establish design and construction criteria of specific sites. Some symbols may not appear on this map because the description is applicable to a series of maps.
